**TYPE B ACCIDENT INVESTIGATION
BOARD REPORT OF THE
DECEMBER 15, 1997, LEAKAGE OF
WASTE CONTAINERS NEAR
KINGMAN, ARIZONA**

U.S. Department of Energy
Fernald Environmental Management Project

Type B Accident Investigation Board Report of the December 15, 1997 Leakage of Waste Containers Near Kingman, Arizona

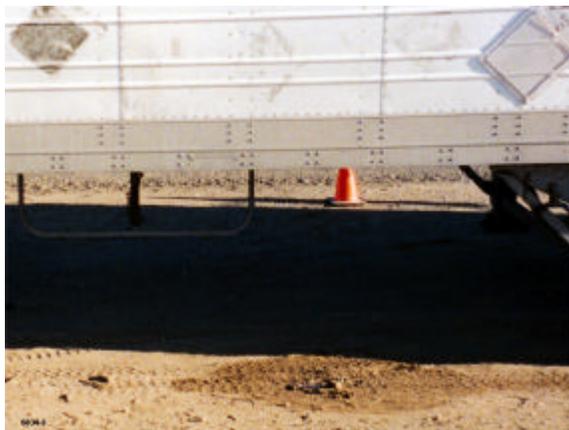
The event occurred as a shipment of seven White Metal Boxes containing low level radioactive waste was en route from FEMP to NTS. The truck driver identified the leakage of an unknown liquid from his trailer as he was preparing for a routine stop near Kingman, Arizona. There had been no observable leak at his previous inspection stop, approximately 370 miles before. He parked the truck adjacent to the Petro Truck Stop at Exit 66 of Interstate Highway 40 and notified FDF at 1654 Eastern Standard Time.⁴

Figure 2-1 The Leaking Trailer

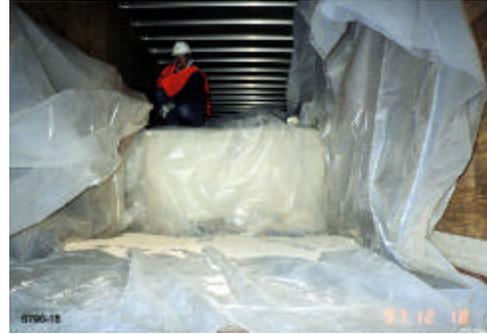
On Tuesday, December 16, attempts were made to use a field expedient patch of epoxy on the White Metal Box at the rear of the trailer that had been identified as a leaker. Alternate plans for recovery of the shipment were still being developed at the FEMP by the recovery organization that included use of NTS assets or use of an emergency response contractor.

Figure 2.2 Leaking Containers Within a Plastic Overwrap

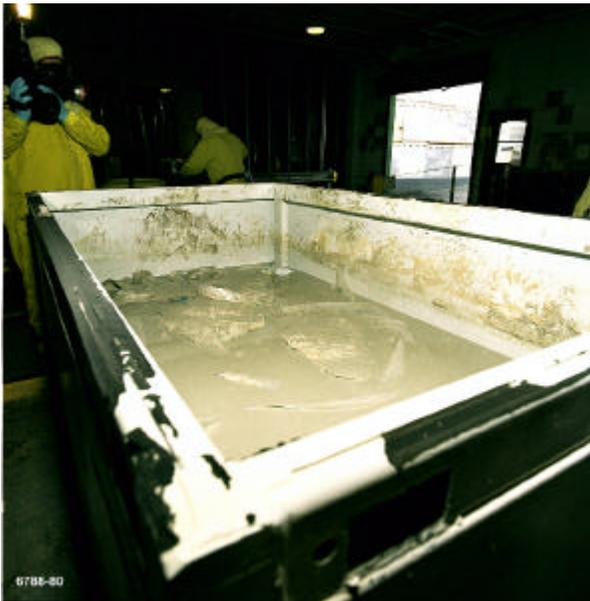
Figure 2-3 Box 483004 After Return to the FEMP

After weighing, all seven waste containers were examined using real time radiography. While the other containers from the shipment showed no free liquid, Number 483004 showed evidence of liquid on top of the waste. Containers 483004 and 483141 were moved to Building 71 where they were opened. Visual examination confirmed that free liquid was present in Number 483004, but not Number 483141. The waste was removed from both boxes and placed into drums.

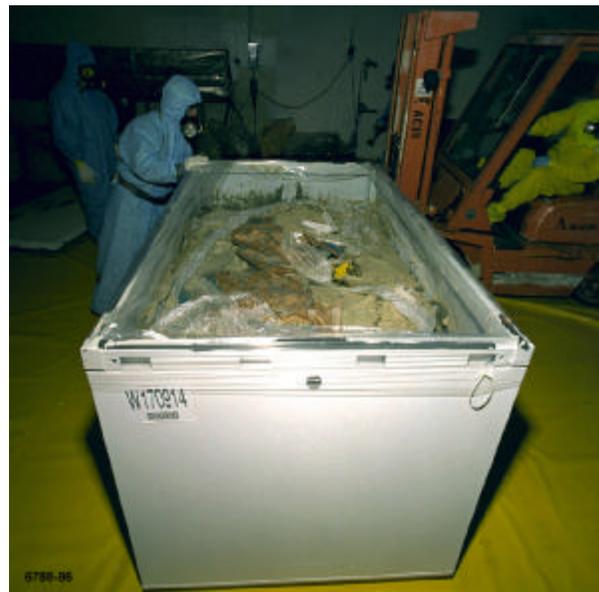
Figure 2-4 Box 483141 After Return to the FEMP

After unloading the waste, samples of both of the failed areas of container 483141 were removed. One was sent to the manufacturer for analysis. Later, the Board had the other failed area of 483141 sent to Sandia National Laboratories/New Mexico for independent analysis. The results from the analysis of the sample of 483141 provided to Sandia National Laboratories/New Mexico are discussed below. The results of the manufacturer's analysis of the other sample were unavailable in time to be evaluated by the Board.

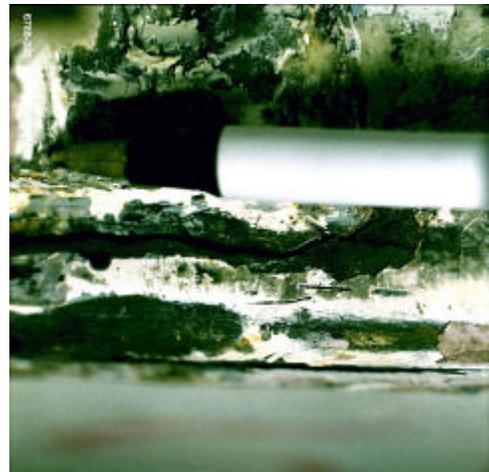
The area immediately surrounding one of the failures on container 483141 was sent to Sandia National Laboratories/New Mexico for analysis. The Laboratory performed stress and metallurgical analyses on the waste container design and materials.

- The static load of stacking one 6,000 pound container on top of a container loaded with 4,800 pounds of material (a common practice at FEMP) will cause yielding in the region around the end of the center runner (see Figure 2-6). The Sandia report goes on to state that adding a slight (2g) dynamic effect while stacking the top box is enough to cause failure.

Figure 2-5 One of the Cracked Areas on Container 483141

- If two containers weighing 6,000 pounds each are stacked on top of a container loaded with 4,800 pounds of material, the bottom container will fail, even if no dynamic loading is experienced.
- A loaded container with no other containers stacked on it would be unlikely to experience structural failure, unless a dynamic load of 4g or greater were applied.

- The materials used to construct the container met the American Society of Testing and Materials chemical specifications, exhibited microstructures and hardnesses consistent with expectations, and exhibited sound welds. There was no evidence that materials or welding deficiencies were the primary cause of failure of the container.

- The preponderance of evidence indicates that the primary crack resulted from combined bending and shear stresses that exceeded the yield and ultimate strength of the material, resulting in ductile overload failure.

- Stress corrosion crack growth occurred subsequent to initial crack formation. This growth may have occurred during storage, transport, or both.
- The vibrations and cyclic loads experienced during transportation caused the mating crack surfaces to repeatedly rub over one another, resulting in wear and the effective widening of the crack to the point where leakage occurred.

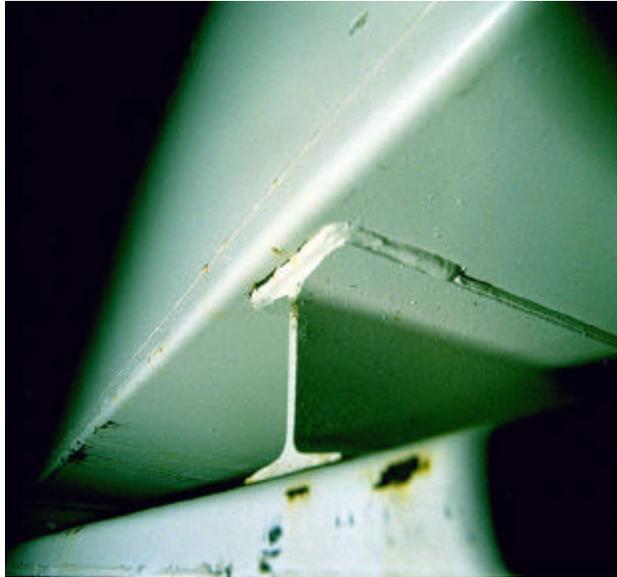
Figure 2-6 Loaded Container Showing Indications of Paint Cracking

The Board examined a number of containers stacked and awaiting shipment at FEMP. Loaded waste containers stacked in Plant 6 were examined. These containers contain uranium materials awaiting shipment to British Nuclear Fuels, Limited. Many of these exhibited cracking and spalling of paint and inward displacement of the base plate at the end of the center runner. In addition, a number of loaded waste containers awaiting shipment to NTS were examined in Building 30A. Paint cracking and rust was visible in approximately 1/3 of these containers at the ends of the center runner. A typical observation is shown in Figure 2-6.

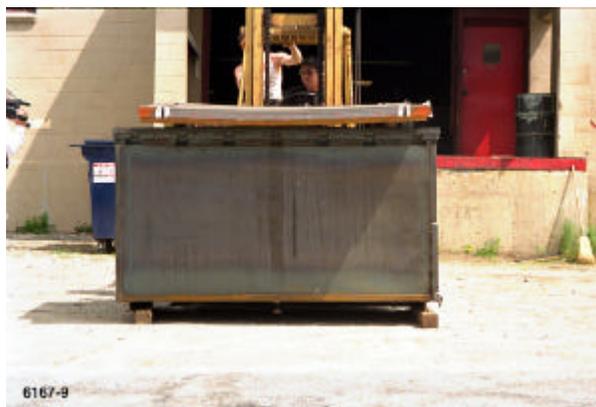
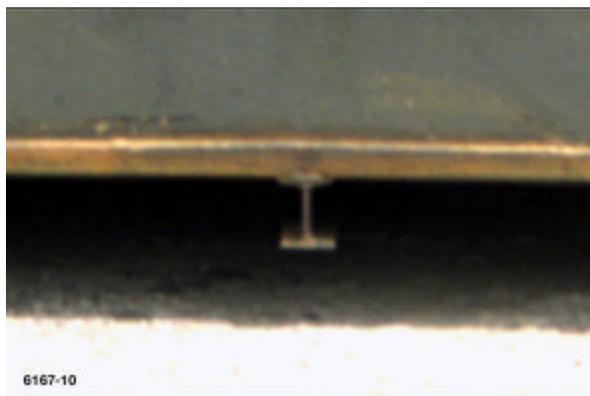
Figure 2-7 The Metal Container Tested

Figure 2-8 Closeup of Center Runner Area on the Metal Container Tested

The Request For Proposal was issued to sixteen offerors, both large and small businesses. Nine proposals were received on May 5, 1995. The evaluation included performing the required tests against sample containers supplied by CGR Compacting, Inc. (CGR). (CGR was the lowest qualified bidder). The sample containers successfully completed all the required tests. CGR noted that 11 gauge steel was required to pass the specific vibration test, rather than the minimum of 12 gauge steel required by the Request For Proposal. Pictures taken during the testing of the CGR samples show the runners flush with the side walls of the container (See Figures 2-7 and 2-8).
